# Markings of the Turning Point: Preserving the Last Surviving Example of Invasion Stripes on a World War II Bomber

Karen Wilcox and Lauren Horelick, National Air and Space Museum (Smithsonian Institution)

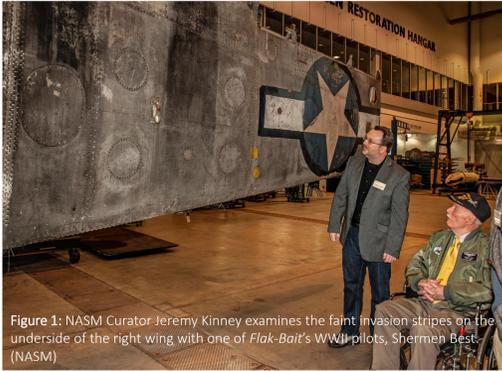
Figure 1: NASM Curator Jeremy Kinney examines the faint invasion stripes on the underside of the right wing with one of *Flak-Bait*'s WWII pilots, Sherman Best (NASM)

**INTRODUCTION.** The Martin B-26B Marauder *Flak-Bait* is an iconic artifact of World War Two (WWII) with exceptional originality. It retains signs of wear and tear from surviving over 200 missions. This includes the faint black and white stripes on the wings and fuselage (e.g. *fig. 1*). NASM curators believe these are the only surviving example of the distinctive ‘Invasion Stripes’, which were painted on Allied planes to prevent friendly fire during the D-Day invasion of Normandy in June 1944. Our goal is to preserve all evidence of *Flak-Bait*'s service life as it appeared after its final flight (*fig. 2*). However, the overall camouflage paint was applied at manufacture without a primer, and, after severe weathering, both it and the Invasion Stripes are unstable and in need of conservation.

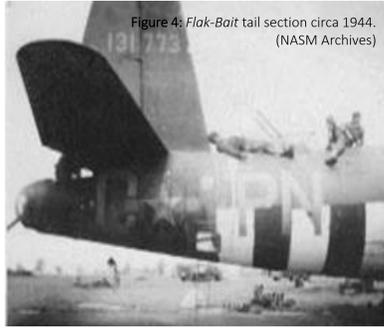
Figure 4: *Flak-Bait* tail section circa 1944. (NASM Archives)

**HISTORICAL RESEARCH.** Archival footage of a U.S. Troop Carrier Wing recorded the stripes being marked out and painted (*fig. 3*). Memoirs described using ‘cans of paint, masking tape and brushes’, even improvising with brooms when supplies ran out,<sup>1</sup> whilst others mentioned spraying the paint.<sup>2</sup> Orders from late 1944 indicated the stripes were supposed to be removable but cautioned some tenacious paint may remain,<sup>3</sup> and the stripes on *Flak-Bait* did wear off over time (*figs. 4-5*). Two types of temporary marking paint were available:

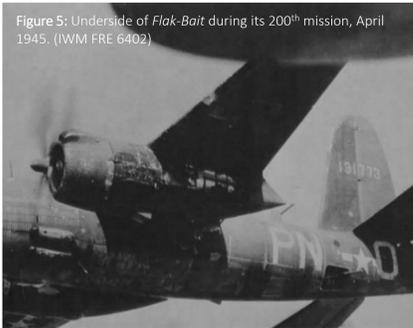
Figure 5: Underside of *Flak-Bait* during its 200<sup>th</sup> mission, April 1945. (IWM FRE 6402)

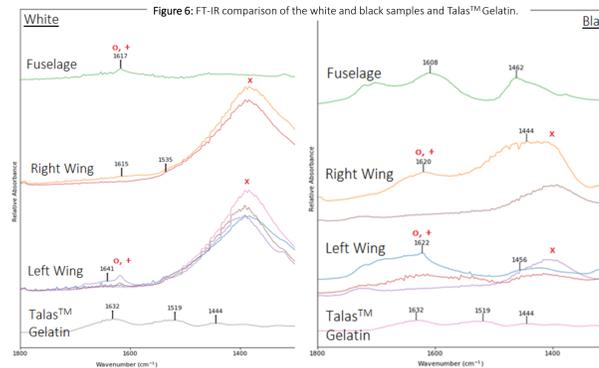
Figure 6: FT-IR comparison of the white and black samples and Talas™ Gelatin.

**1. Masking.** LC-MS indicated proteins in some samples, although the attribution was problematic. However, in the results of the FT-IR analysis (*fig. 6*), the characteristic amide peaks seen in Talas™ Gelatin are indistinguishable from the inorganic peaks for calcium carbonate (x), barium sulfate (o), and calcium sulfate (+). This is likely true for any binder with identifying peaks in this area, such as drying oils with a key peak around 1730cm<sup>-1</sup>.

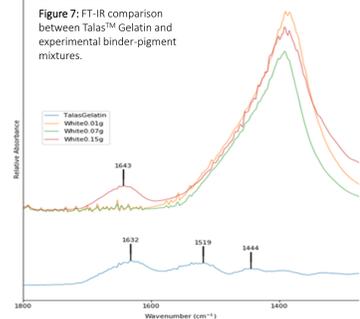
Figure 7: FT-IR comparison between Talas™ Gelatin and experimental binder-pigment mixtures.

**2. Minimal binder and instrumental limits.** Weathering can remove binders, particularly if it is water-soluble. Experimental mixtures of calcium carbonate (1g) and Talas™ Gelatin (0.01g, 0.07g, 0.15g) in deionized water were dried to a film and analyzed with FT-IR (*fig. 7*). The first amide peak is only detectable with our instrument at the highest concentration (13%), which would compound issues of masking.

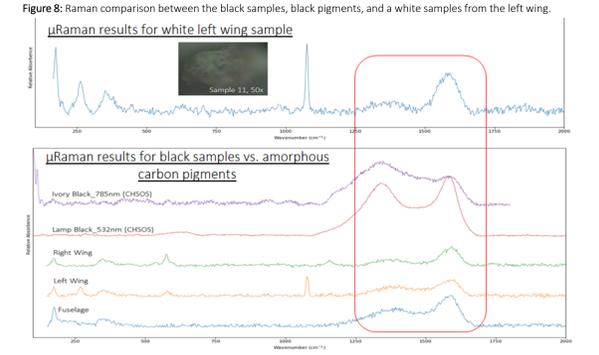
Figure 8: Raman comparison between the black samples, black pigments, and a white samples from the left wing.

**3. Contamination.** Lead (Pb) was found but not lead white. We wonder if this might be contamination from leaded gasoline. Amorphous carbon pigments such as lamp black or ivory black were the most common black colorants in the period, but the characteristic peaks in the Raman analysis also appear in a white sample collected near one of the engine coverings (*fig. 8*). This could be an error of the analysis or burnt hydrocarbon residues.

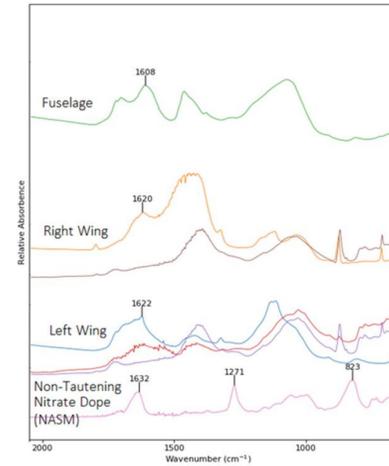
Figure 9: FT-IR comparison between the black samples and Nitrate Dope (unknown brand).

**4. Few comparable studies.** British ‘Night’ paint was supplied as distemper or cellulose nitrate formulations. The three characteristic FT-IR peaks for nitrocellulose seem absent (*fig. 9*). In studies of nitrate plastics these persist even when degraded.<sup>11</sup> But, there are no studies of vehicle paints demonstrating how distinct these peaks should be in a mixture that was only partially binder even before weathering and the dominance of the inorganic components.

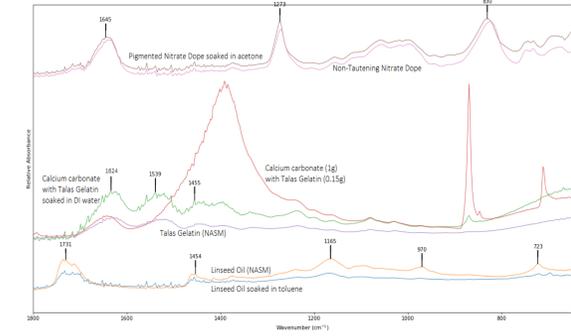
Figure 10: FT-IR comparison between known formulations after extraction and linseed oil, non-tautening nitrate dope, and Talas gelatin.

**5. Experiment to improve FT-IR results using solvent extraction.** Known binder-pigment mixtures were soaked in solvent overnight, the liquid pipetted onto a glass slide, and the dried film analyzed with FT-IR (*fig. 10*). As expected from their solubility, acetone seemed to extract nitrate dope, toluene extracted the linseed oil, and deionized water extracted gelatin. In the last, calcium carbonate originally masked the binder, but after extraction the characteristic amide peaks are clearly visible.

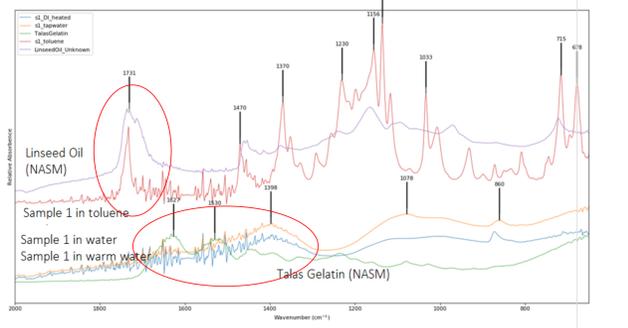
Figure 11: FT-IR comparison between samples extracted in toluene and linseed oil, and samples extracted in deionized water and deionized water after heating with Talas™ Gelatin.

The method was repeated for a white sample from the left wing (*fig. 11*). Only very small fragments were used, and we would expect minimal binder, but it still produced poor results. Toluene may have produced a clearer drying oil peak around 1730cm<sup>-1</sup>, but it was still not a definitive match. Even though this sample had the most consistent results for proteins with LC-MS, no amide peaks appeared with the deionized water, even when gently heated (50°C) on a hotplate for 2 hours to promote dissolution.
